## HEADLINING

### RENEW

76.64.01

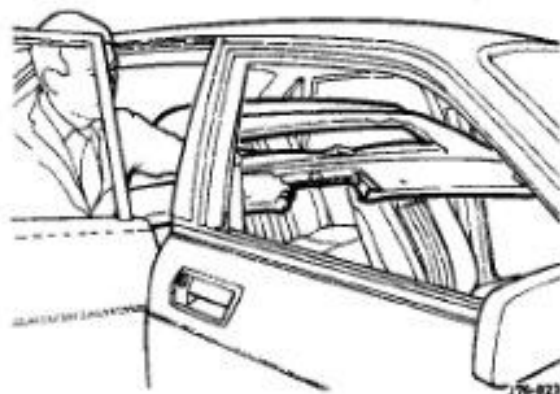
Fig. 1 Rear corner through passenger rear door opposite corner through driver side rear door.

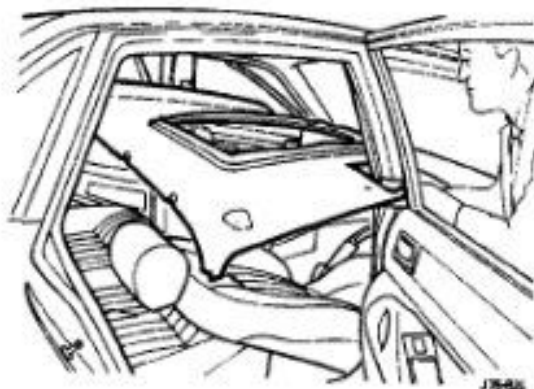
Fig. 2 Across car with console cut out straddling 'B' - 'C' post.

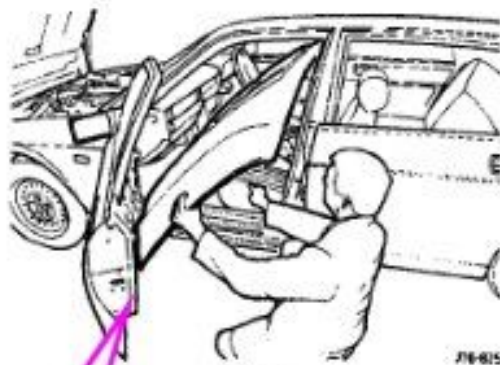
Fig. 3 Tip forward against fascia tie bars with rear edge diagonally across door aperture.

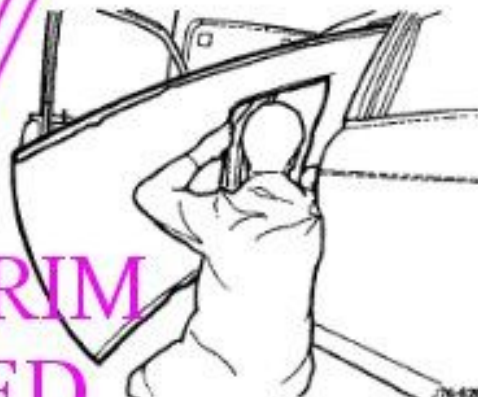
Fig. 4 Feed the headlining out of the passenger front door, carefully easing the edge cutouts over door aperture and fascia tie bars.

**NOTE THE DOOR TRIM  
HAS BEEN REMOVED**
